Service manual  
VRV IV+ Heat Pump

**VRV IV<sup>+</sup>**

RYYQ8U\*  
RYYQ10U\*  
RYYQ12U\*  
RYYQ14U\*  
RYYQ16U\*  
RYYQ18U\*  
RYYQ20U\*

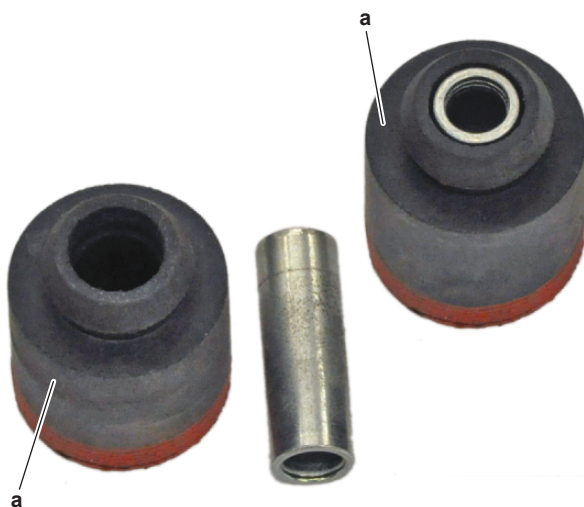
5 Check the compressor dampers for any damage.

a Damper

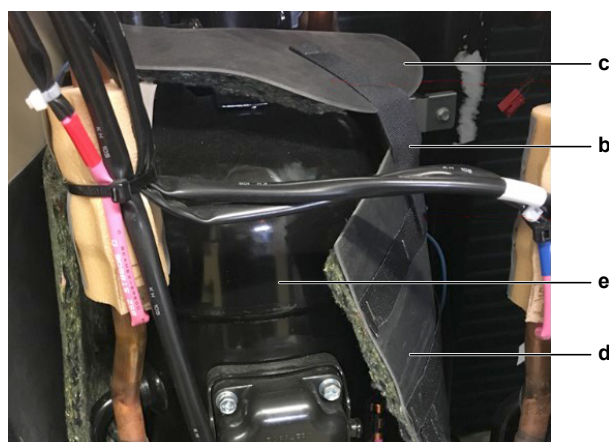
- 2 Detach the strip of the top jacket.
- 3 Remove the top jacket.
- 4 Remove the body jacket from the compressor.

**b** Strip  
**c** Top jacket  
**d** Body jacket  
**e** Compressor

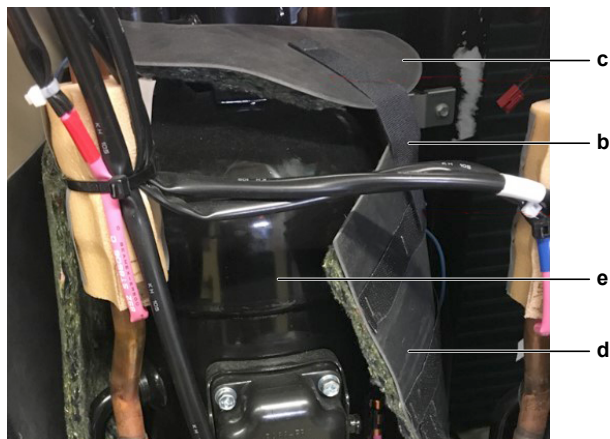
### To install the compressor insulation

- b Strip
- c Top jacket
- d Body jacket
- e Compressor

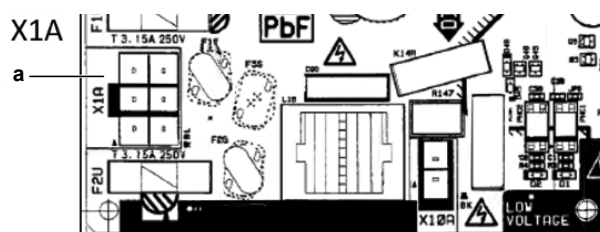
- 1 Turn ON the power of the unit.
- 2 Measure the voltage between the following wires on connector X1A of the main PCB. All measurements MUST be 230 V AC $\pm$ 10%.
  - L3 (pin 1)–N (pin 5)
  - L1 (pin 3)–N (pin 5)

a Connector X1A

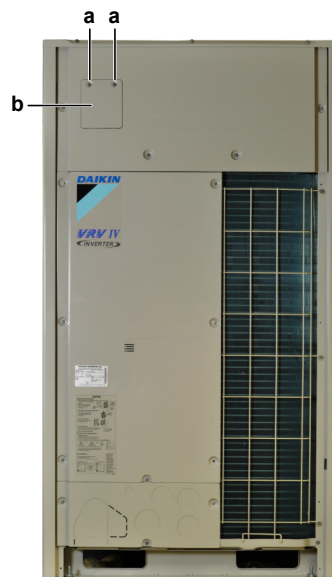
#### To remove the service plate

- a** Screw
- b** Service plate

- 1** Loosen and remove the 2 screws that fix the service plate assembly.
- 2** Remove the service plate assembly from the unit.
